Embankment dams in Canada

V. Milligan - *Golder Associates, Canada*
C. F. Ripley - *Consulting Engineer, Canada*

The paper reviews the development of embankment dams in Canada. By using selected case examples, it demonstrates that problems in design and construction of embankment dams in Canada are largely related to geology, particularly glacial geology, and to severe climatic conditions. Solutions to these problems have been innovative, advancing the state-of-the-art and providing valuable experience to the profession.

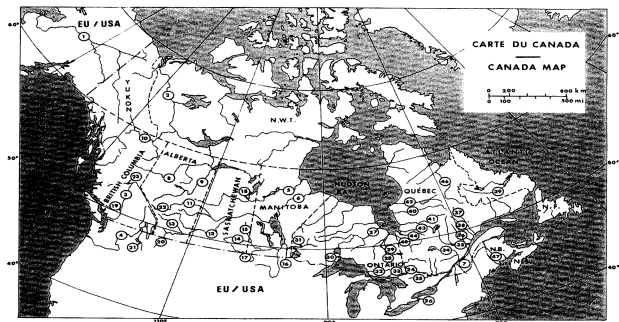
Fig. 1. Embankment dams (higher than 15 m) built per decade in Canada since 1900

The majority of the dams now built are of the embankment type. Most have been built for hydroelectric power generation. Two projects accelerated the design and construction of fill dams. In the period 1968 to 1972, some 88 earth and rockfill dams and dykes totalling about 64 km in overall length were built for the Churchill Falls Power Project in the Canadian Shield of Labrador, only 50 per cent of these being over 15 m in height (McConnell et al., 1973). In the period 1976 to 1982, over 80 earth and rockfill dams and dykes were constructed in Québec, in the heart of the Canadian Shield, as part of the James Bay Hydroelectric Project (Paré et al., 1997). Many of these dams were of significant size, the highest being LG-2 Dam, a 168 m high rockfill completed in 1978 on La Grande Rivière.
